Sidewall Cord Impact Break (Bubble)

NEXEN TIRE

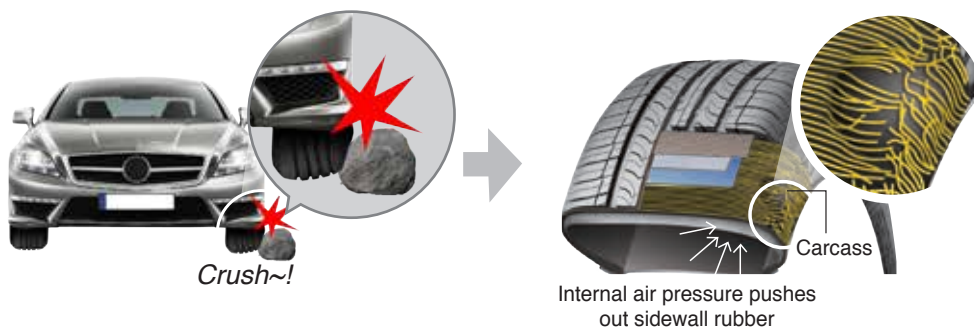
The carcass contains textile cord topping layers between steel belt and inner liner. If the textile cords of carcass are damaged due to sudden impact with a road hazard or a pothole, the sidewall of tire may arise like bump. This is why the internal air pressure pushes the surface through the gap in the cord. This is called Cord Impact Break(Bubble).

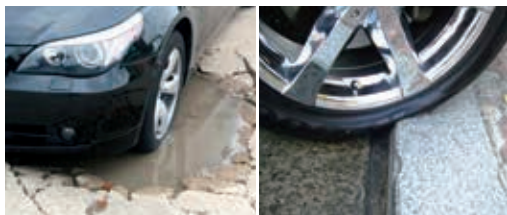
Possible Causes

Impact damage such as curb / pothole

Avoid tread surface cuts and pothole impact if possible.

Drive on harsh bumpy road at low speed.

Maintain proper tire inflation pressure.

Check the tire for damage frequently.

Avoid contact with curbs.

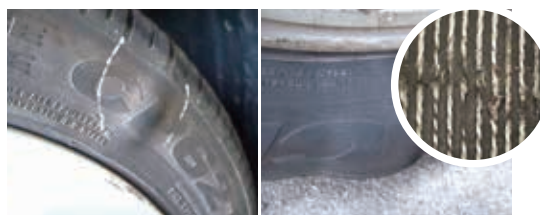
Result

Localized protrusion in the sidewall

⚠ It is very dangerous to drive in the condition of cord impact break.
